**MARYLAND HISTORICAL TRUST
DETERMINATION OF ELIGIBILITY FORM**

Property Name: Holy Rosary Roman Catholic Church Complex Inventory Number: B-5122
Address: 400-440 S. Chester Street Historic district: ☐ yes ☒ no
City: Baltimore Zip Code: 21231 County: Baltimore City
USGS Quadrangle(s): Baltimore East
Property Owner: Roman Catholic Archbishop of Baltimore Tax Account ID Number: 02091774016
Tax Map Parcel Number(s): _____ Tax Map Number: 2
Project: Red Line Corridor Transit Study Agency: Mass Transit Administration
Agency Prepared By: John Milner Associates, Inc.
Preparer's Name: Katherine Larson Farnham Date Prepared: 1/23/2006
Documentation is presented in: Enoch Pratt Free Library--Maryland Room vertical files
Preparer's Eligibility Recommendation: ☐ Eligibility recommended ☒ Eligibility not recommended
Criteria: ☐ A ☐ B ☐ C ☐ D Considerations: ☐ A ☐ B ☐ C ☐ D ☐ E ☐ F ☐ G
Complete if the property is a contributing or non-contributing resource to a NR district/property:

Holy Rosary Roman Catholic Church Complex

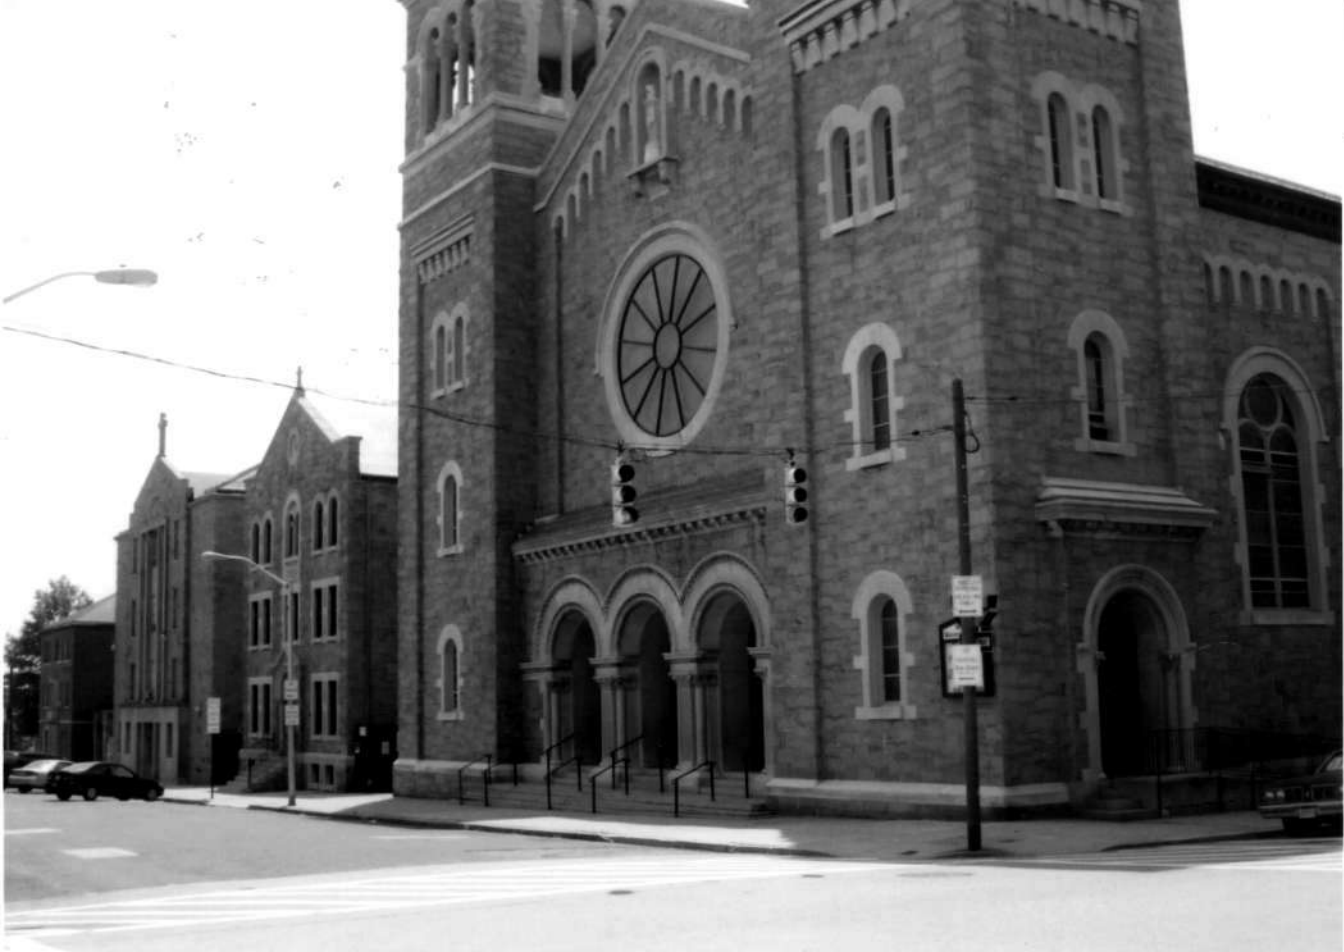
#1 of 7

View of full complex to SW

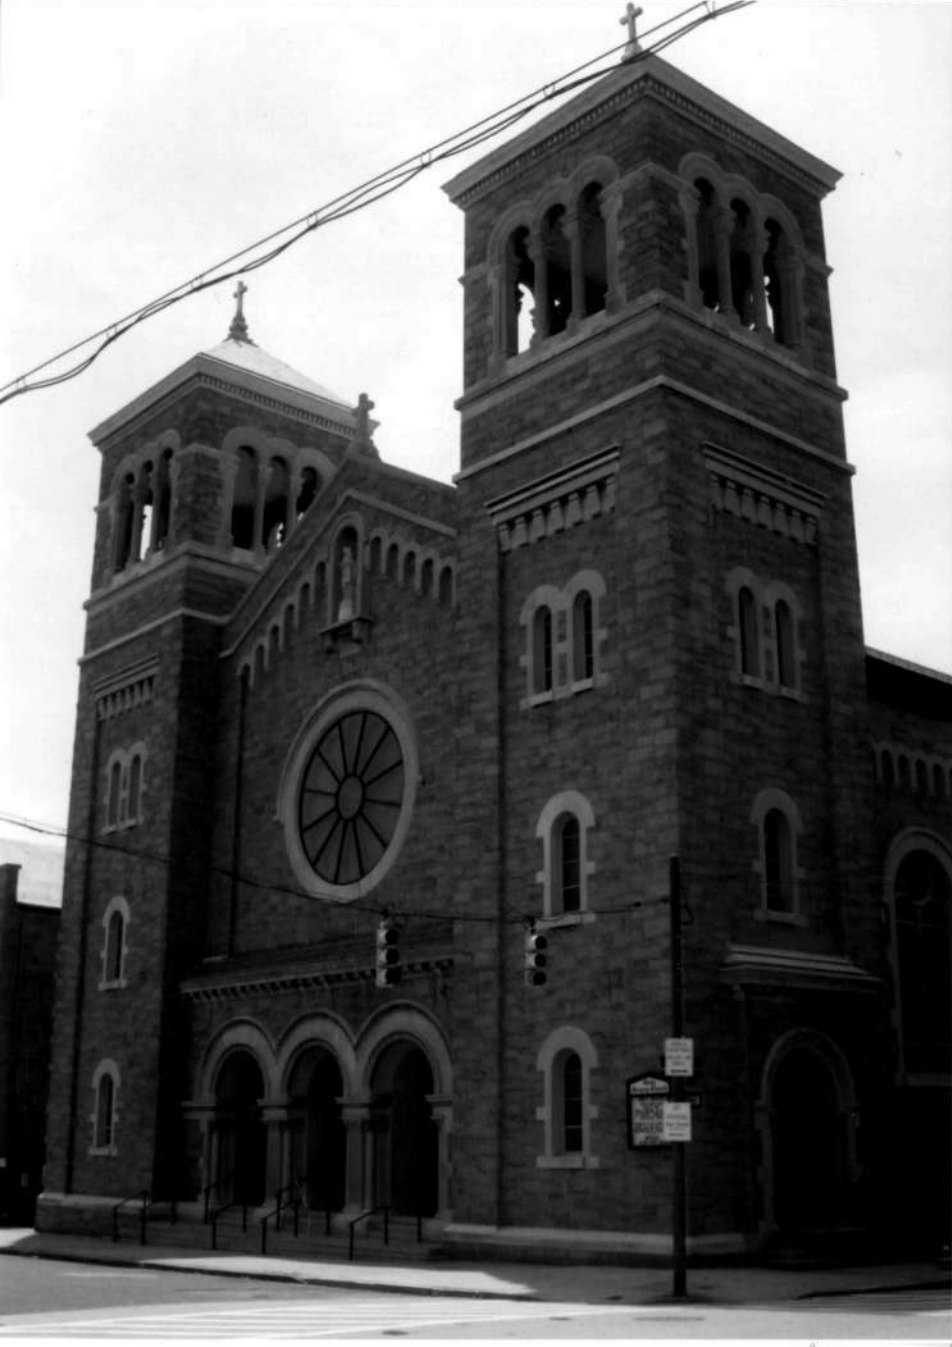
#2 of 7

Holy Rosary Church is a large three-story gable-front Romanesque Revival church with twin four-story bell towers flanking the central entrance. The entire building has a slate roof and is sided with rough-faced ashlar granite masonry laid in broken ranges and trimmed with light-colored limestone. The main block is three bays wide, and the towers, which project from the building corners, are each one bay wide and one bay deep. The nave has a parapeted gable roof and arcaded stone trim along the cornice of both the gable and the side walls. The front gable contains a shell-carved niche with a Virgin and child statue, and the second and third floors are occupied by a large rose window. Below the rose window is a steep shed-roofed full-width entrance portico with three elaborately trimmed Roman arched entrance apertures. Each entrance has a Corinthian colonette on each side, delicate bands of classical carved stone trim, and a recessed double door with semicircular transom. The doors are three-panel carved oak doors, and the transoms are stained glass with a center circular window within them. Between the entrances are fluted pilasters. Each of the two bell towers has a pyramidal roof with a cross finial, triple Roman arched openings on the top level housing the bell

View of chwd. to SW

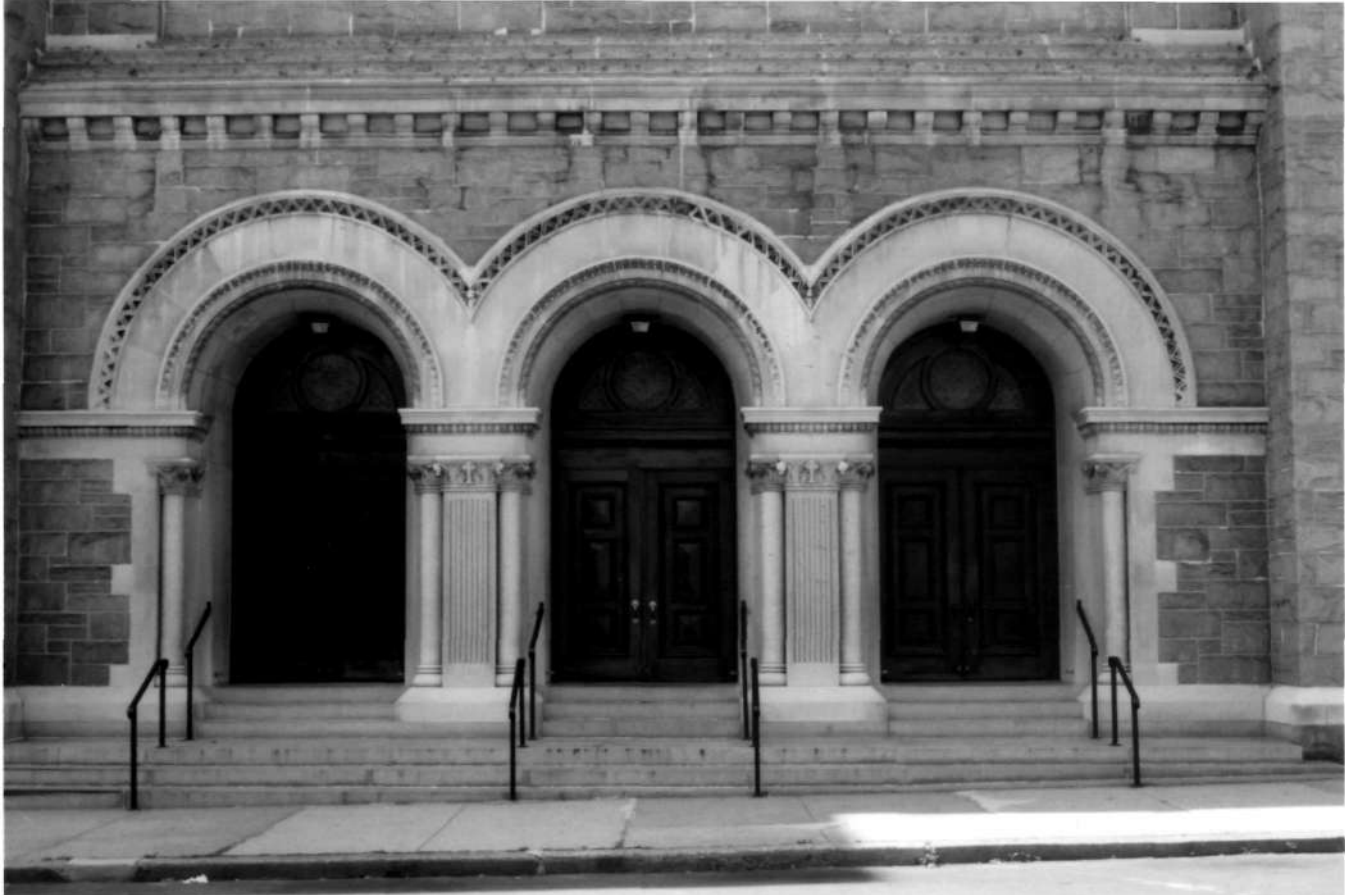
#3 of 7

carillons, and recessed center sections on the first through third levels with stone scroll trim at the top. The third floor levels have paired Roman-arched windows, and the two lower levels have single windows that are larger in size. The north side of the north bell tower has a shallow hip-roofed portico projection and a single round-arched entrance with a double-leaf door similar to those on the front. The church nave is six bays deep with two-story Roman arched windows and small basement windows below a stone belt course. At the rear of the church is a two-story semicircular apse and a one-story-plus-basement hip-roofed sacristy space which wraps around the apse.

Detail of choral entrance bays, to W

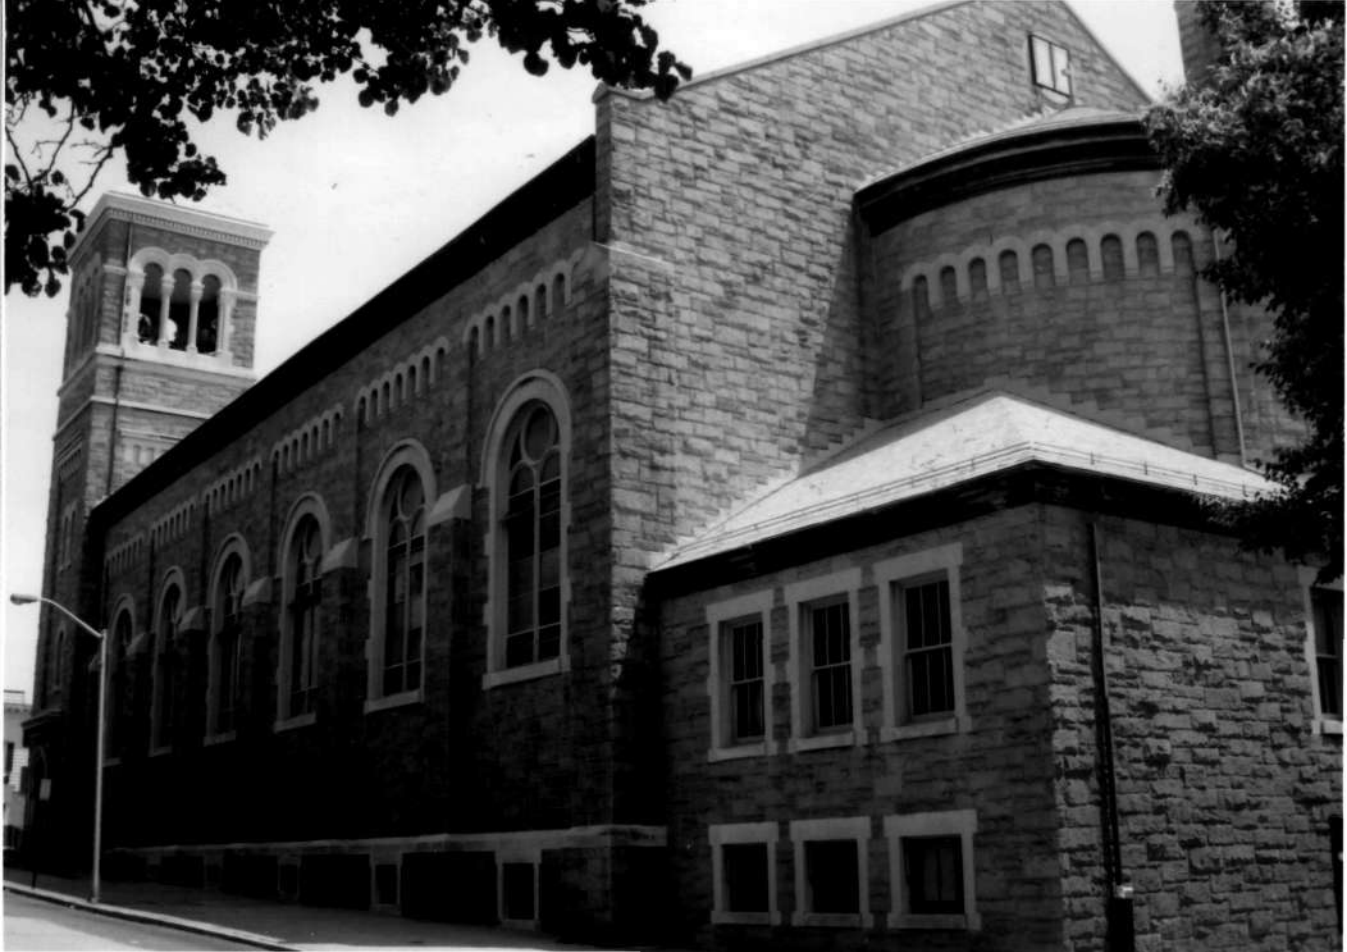
#4 of 7 019

Rear/side view of church, to SE

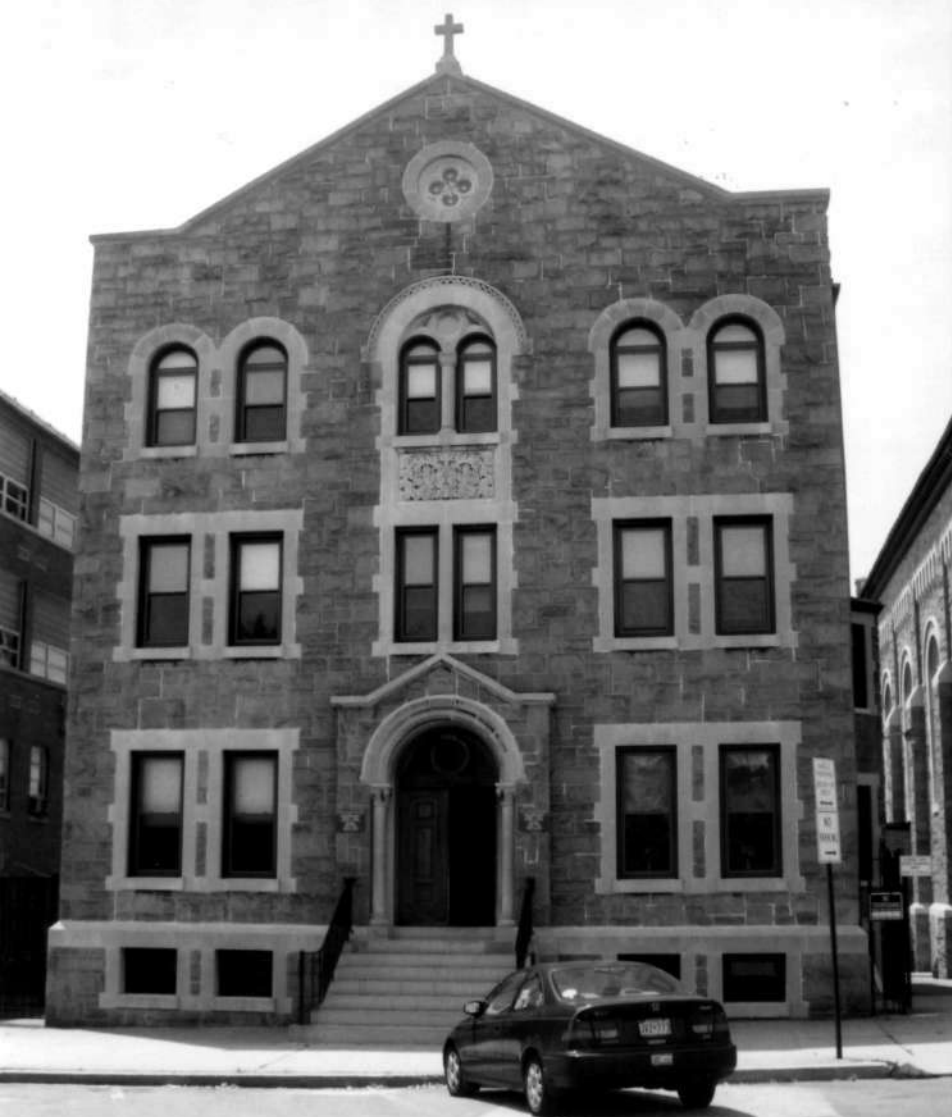
#5 of 7 B&E

Directly south of the church is the rectory, a gable-front Romanesque Revival structure with a slate roof and broken range granite stonework similar to that on the church. The rectory is three-and-one-half stories in height, including an English basement level. The front façade is six bays wide on the two top floors, and five bays wide on the first floor, which has a Roman arched recessed center entrance with carved double-leaf three-panel doors and a semicircular transom similar to entry doors on the church. Stone steps lead to the doors. Windows throughout the building are one-over-one double-hung dark-colored metal sash with stone sills and flush crenelated stone surrounds. The top floor windows have demilunette transoms, and the center two bays on the top two floors are set within a common Roman-arched surround with intricate vine-lead carvings between the two floors. The gabled front parapet has a stone cross at its peak with a quatrefoil ornament carved into the gable end. The basement level projects from the rest of the building and has a carved stone water table on all sides. The rectory is 6-7 bays deep and its north side has two full-height exterior chimneys with a bay window between them.

Front view of rectory, to W

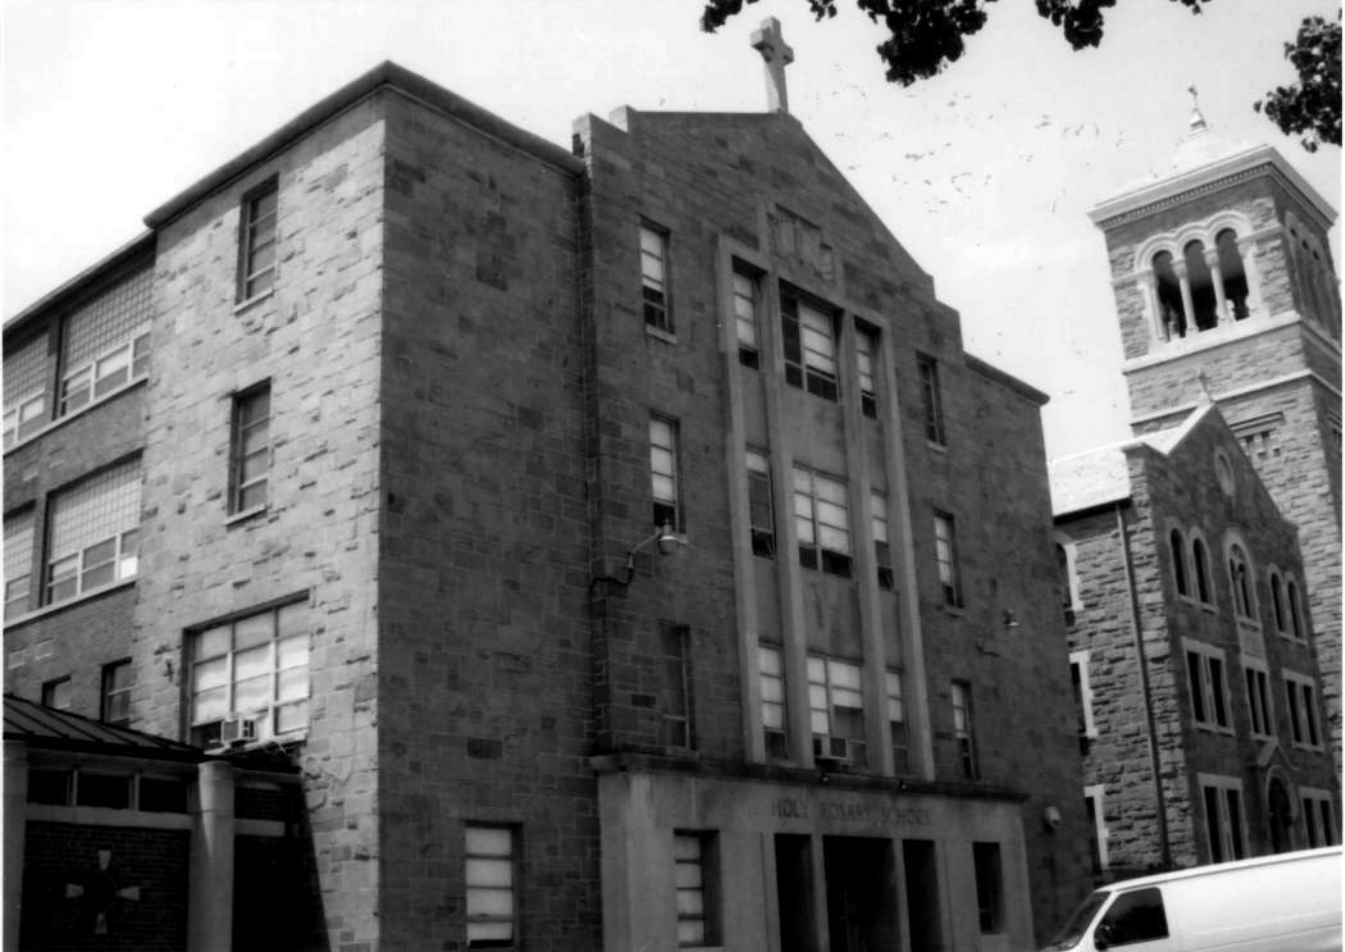
#6 of 7 016

South of the rectory is the 1950s school building, a relatively utilitarian hip-roofed four-story brick structure. Its front is clad in broken-range ashlar stone, while the sides and rear are brick. It has a gabled false-front parapet with a thick stone cross at the peak, and the main hipped roof has asphalt shingles. The parapet is the top of a slightly projecting full-height center section that is five bays wide, and the main block on either side is one bay wide. Windows are original four-light steel and glass sash with some operable awning panels. On the first floor, the center section of the facade is sided with smooth limestone with a simple cornice. It has a recessed triple center entrance with modern commercial glass and steel doors in the center bay. The entrance is flanked by a single four-light steel window on each side within the center section, plus one additional window on each side in the main block. The upper floors have a three-bay stone surround on the center section, which is surmounted by an ornamental stone panel with a carved book motif. The sides of the center section and the main block have ashlar stone siding. The main block has no front windows above the first floor. The front stonework wraps around the corners and extends one bay into the side facades, which are 10 bays deep overall. Behind this bay, the school has brick siding and large windows consisting of bands of three operable metal windows surmounted by a large expanse of glass block. The first and second floors towards the rear contain a two-story gym or auditorium with double-height windows with stone banded surrounds.

View of School to NW

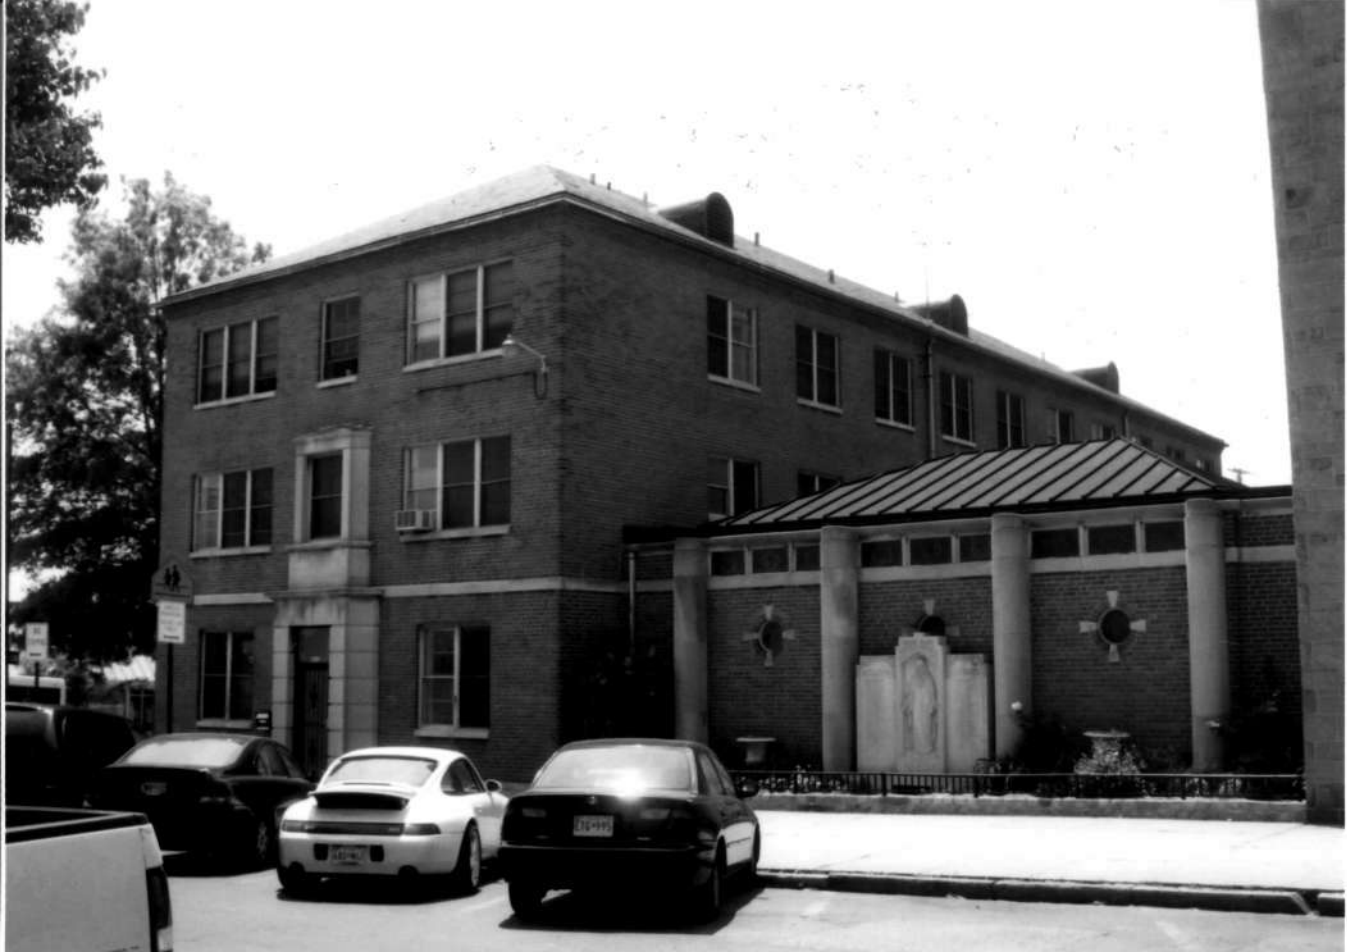
7 of 7

Between the school and the convent is a modern-style one-story pavilion with a hip roof, brick sides, and large exterior plain concrete columns. It is three bays wide in front. The stained glass windows are arranged in a narrow horizontal "clerestory" band at the cornice level, and there is a single stained glass oculus window with keystones below the main windows in each bay. In front of the building is a narrow garden. The center bay contains an exterior marble memorial to parishioners lost in wars.

View of Court + parish hall, to SW
